# MONTHLY SAFETY BULLETIN

MAR-2022

**Zonal Safety Organization  
East Coast Railway, Bhubaneswar**

| Sl No. | ITEMS | PAGE |
|---|---|---|
| 2. | COIL SPRING BREAKAGES IN LHB COACHES, An analytical discussion<br>Sri J.V Appa Rao, Dy.CSO/Mech | 5-12 |

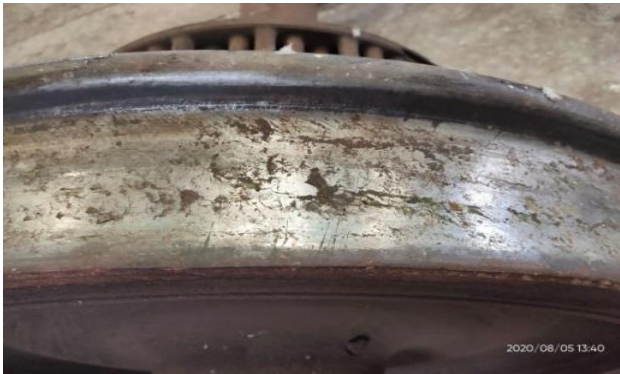
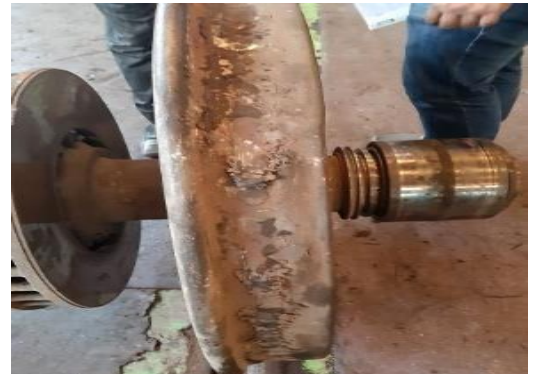
#### **SHELLING & SPREAD RIM**

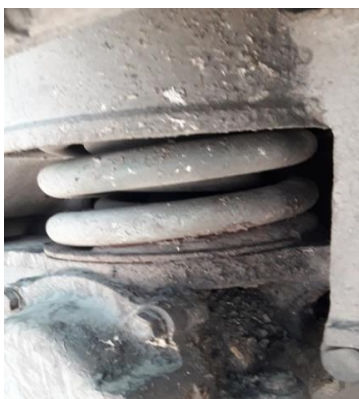
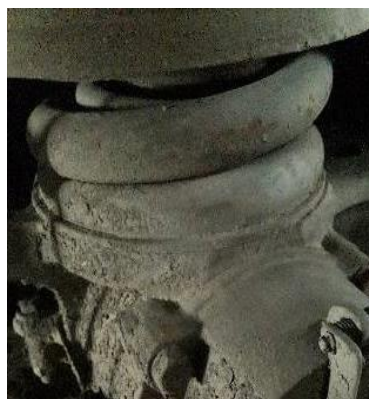
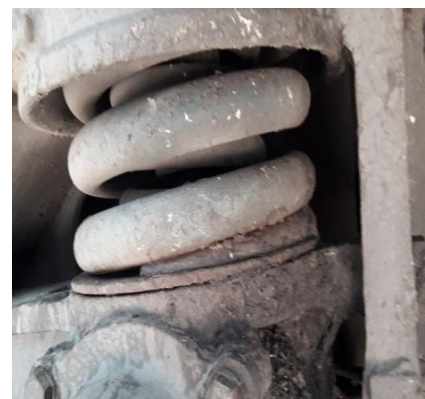
- Cleaning of the springs was not being done, Contact line on the end coils not cleaned properly at depots & workshops before painting.
- Paint repair being done without following the proper painting procedure. Corrosion pits and settling acted as contributory factors towards failures.
- Infrastructure for complete overhauling of springs including load deflection testing for secondary springs, shot peening machines, painting-phosphating tanks etc not available in at workshops.
- Rolling marks were observed on the surfaces of primary and secondary springs. Handling of the springs not done properly and paint gets damaged during handling.
- Parameters i.e. height under test load, alignment deviation and direction of alignment deviation were not being ensured properly at Depots.

- **Improper Cleaning**

- Maintenance as per CMI No. RDSO/2017/CG/CMI-01, including proper pairing.
- *Audit for availability of infrastructure & storage- handling-fitment-maintenance practices for coil springs.*
- *Training.*

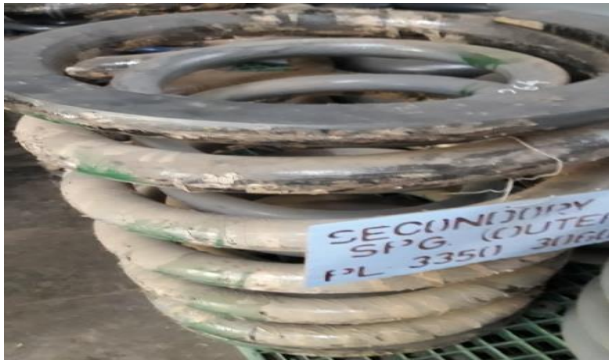
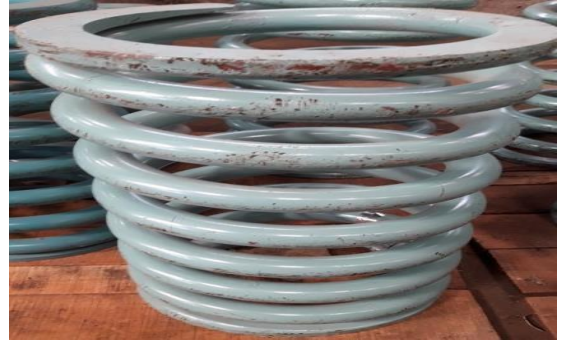
- Improper Storage & Handling

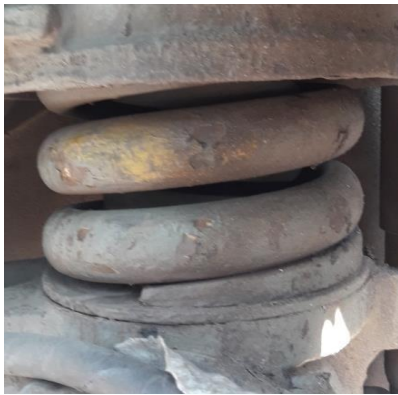
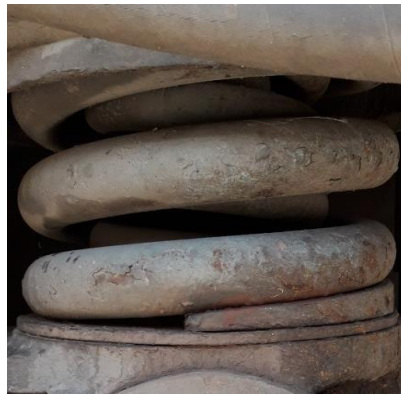
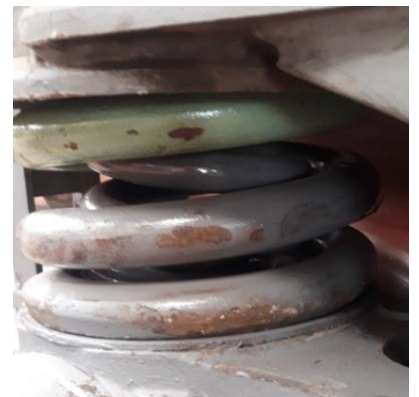
- Corrosion & Pitting

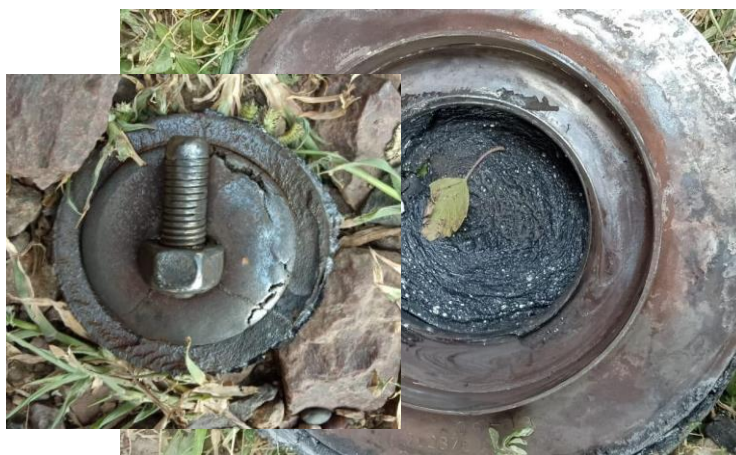
### Condition of rubber bump stop & pads:

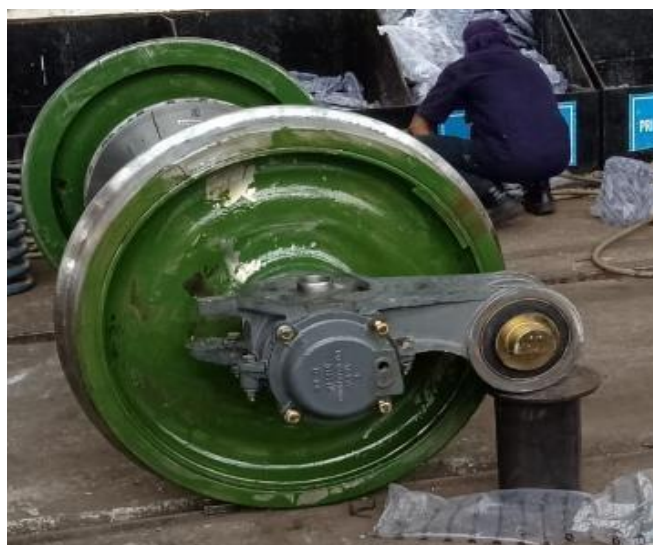
Wrong  
practice

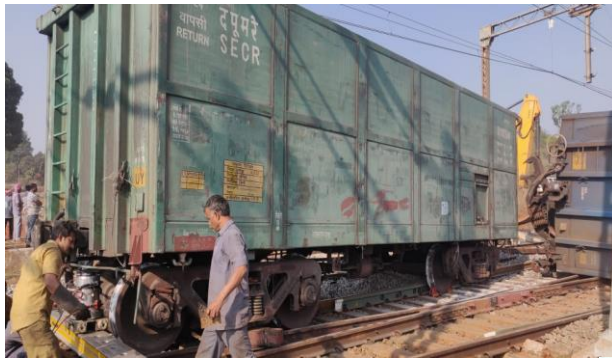
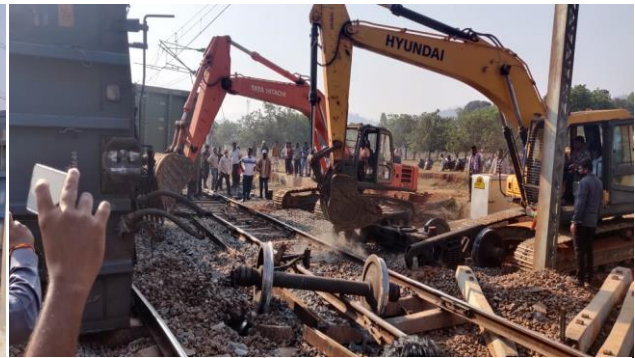
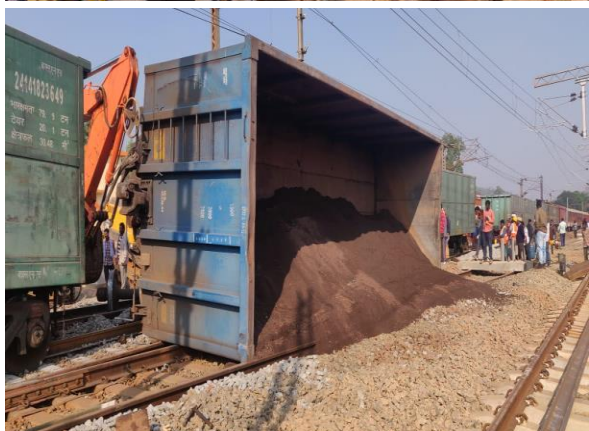
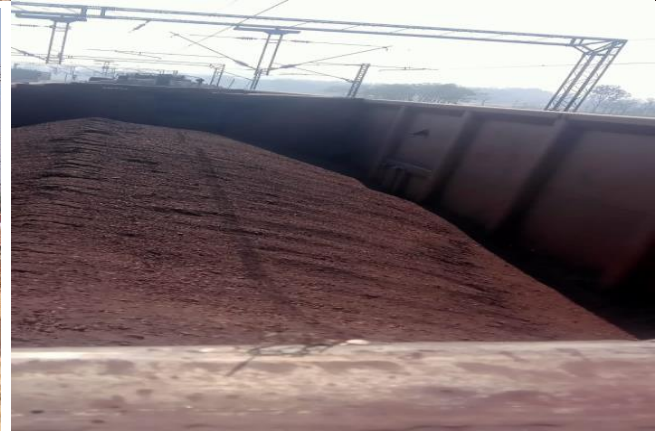
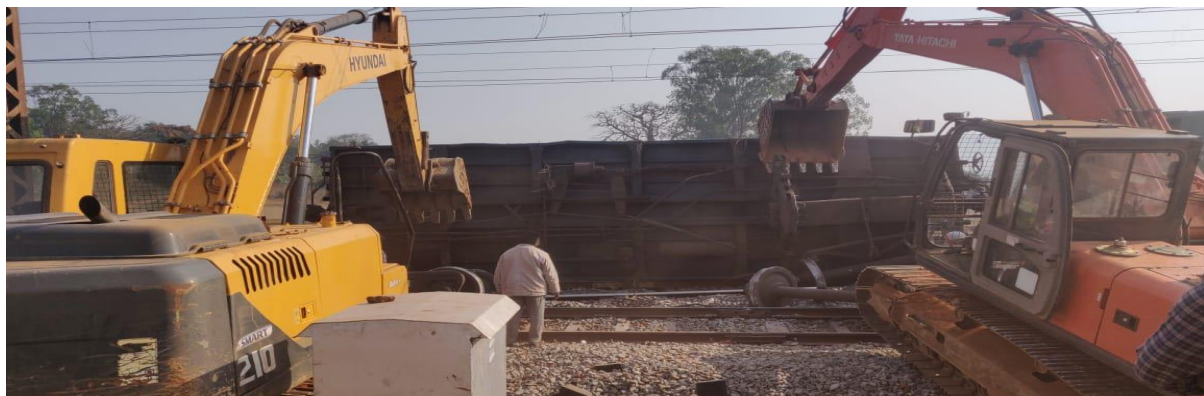
**DERAILMENT DUE TO UNEVEN LOADING & RESTORATION WORK**

| Sl No | Date & Time/ ID | Divn/ Type & Section | Train No | Brief of Accident | Cause | Responsibility | Cost of Damage | Recommendation Action taken |
|---|---|---|---|---|---|---|---|---|
| 2. | 11.03.2022/<br>05 hrs<br>ID:<br>2022031200<br>D-6 | VEJA station<br>yard in KK-1<br>WAT Div | NMGPV-<br>19/G-9 | While admitting in R/3, 06 NBOX load wagons derailed starting from 3 <sup>rd</sup> from engine. | Uneven loading & defect track geometry. | <b>Primary:</b><br>1. NMDC Authority<br>2. Sri R.S Prasad, SSE P.WAY/PFU(IC)<br>3. Sri A.V Rao, SSE/CSL/BCHL | | |

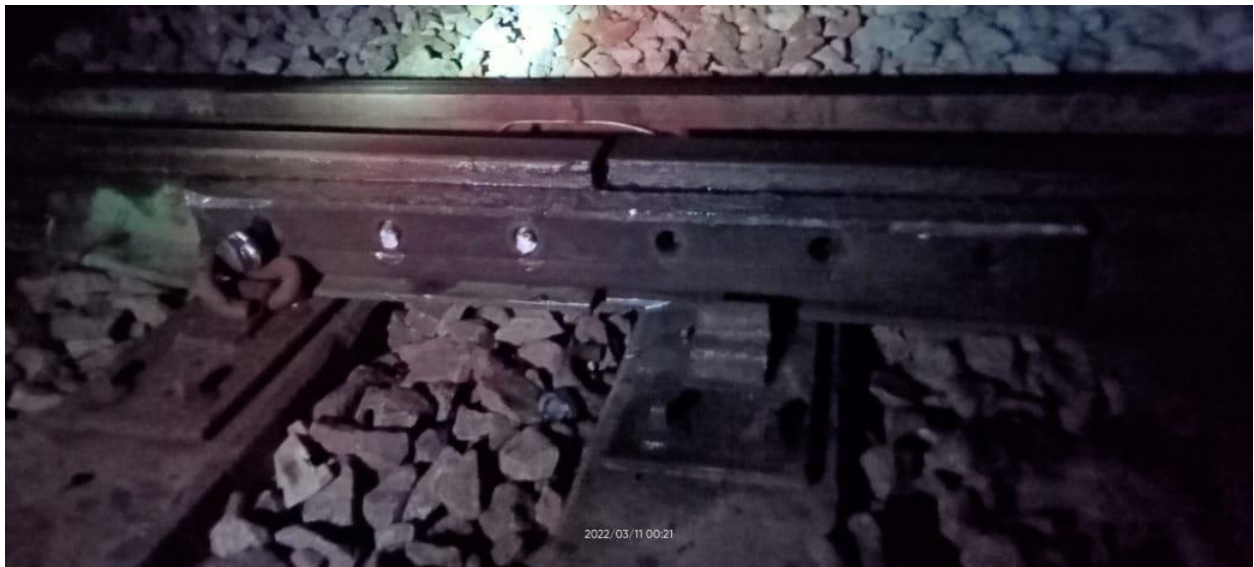
**FISH BOLT BROKEN & MISSING**
