**EAST COAST RAILWAY**

**No:- ECoR/SFY/Alert advice/2023/401**

**ALERT MESSAGE-27**

**Sub:- Lesson learnt from recent Indicative train accidents: SPAD;**

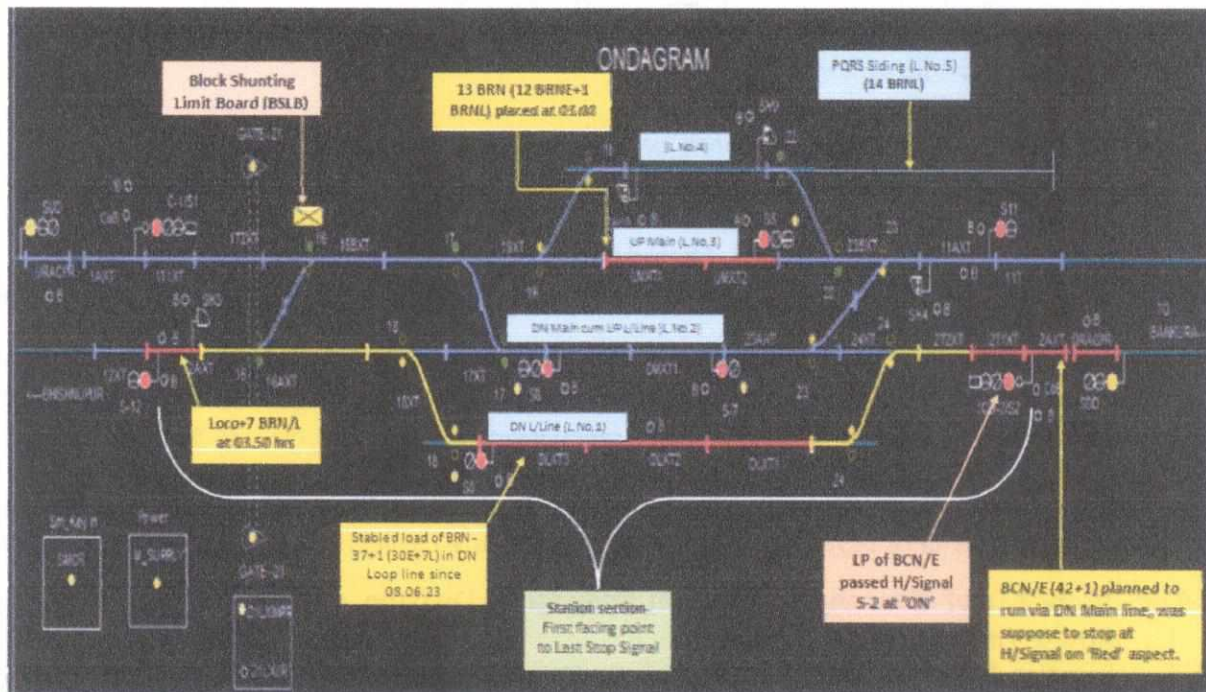
4. **Engine No:** 31798 WAG 9/ Tughlakabad.
5. **Brief Particulars:** While approaching Ondagram station; LP of train No. DN BCN Empty passed DN Home signal No. S-2 of Ondagram station at 'ON' position and dashed in rear of BRN rake (PQRS) which was stabled on DN Loop line resulting derailment of Loco and 8 wagons of train No. DN BCN/E and 06 BRN/E wagons obstructing both up & DN line. No Causality/Injury occurred. Sign On 21:25; Duty hrs 6 Hrs 35 Min; HQ Rest 30 Hrs; Periodic Rest 26 Hrs 5 Min;

6. **Cause:** LP failed to stop the train at DN Home signal for admission into main line after shunting movement which was going on involving DN Main & DN loop line & dashed with stable BRN/E.
