EAST COAST RAILWAY

No:- ECOR/SFY/Alert advice-29/2023/581A

ALERT MESSAGE-29

Sub: - Lesson learnt from recent accidents & unusual incidents in IR.

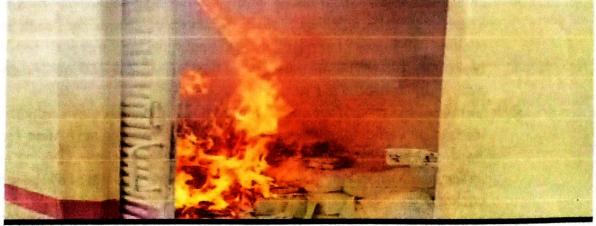
- 1. On 05.08.2023 at 08.54 hrs, Train No.: 18310 DN Jammu Tawi Sambalpur Express, Engine No.: 22885/WAP5-TKD, Load: 22 Coaches (ICF), Section: Ghaziabad Tundla (BG, Double Line, Electrified, A Route, and Automatic) while entering Platform No. 02 at Aligarh station; smoke emission detected in its Parcel Van (VPU), the rearmost vehicle. Affected coach detached immediately. Fire doused at 9.30 hrs with Fire Extinguishers available in train & station. Casuality: NIL
- 2. Cause: JAG level inquiry committee found the incidence of fire occurred due to damage/rupture of casing of loosely packed lithium ion batteries kept under load of other consignments stacked over it. Lithium ion being inflammable gets ignited in presence of oxygen. License of Lessee MGT Cargo (P. K. Gupta), Contract Period: 24.01.23 to 23.01.25 (23Tonne), Awarded by: Sambalpur Division/ECoR was terminated.

4. The following initiatives need to be taken to prevent recurrence:

a. Mis declaration of parcel should be checked & action to be taken accordingly.

b. All parcels should be scanned and labelled safe for transportation before

loading.

c. Provision of CCTV cameras and scanners at the parcel handling stations to be ensured.

d. The operation of scanner and CCTV and monitoring of activities using them should be done by the security personnel. Data of 30 days should be stored by CCTV system.

e. Frequent ambush/random checks should be done by Divisional & HQ

officers to ensure the above.
