## EAST COAST RAILWAY

No:- ECoR/SFY/Alert advice-29/2023/634

### ALERT MESSAGE-30

Sub:- Lesson learnt from recent accidents & unusual incidents in IR & ECoR.

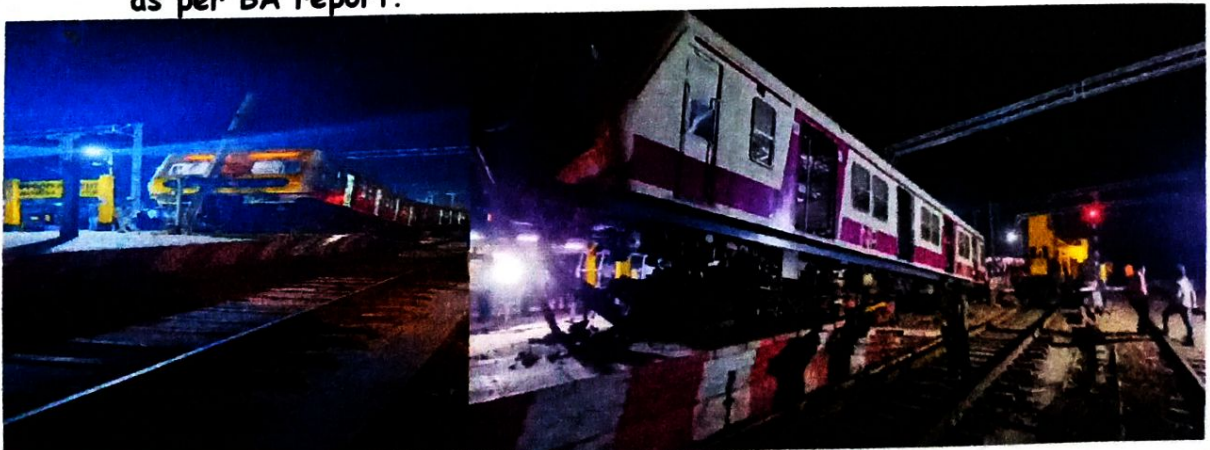
1. On 26.09.2023 at 22:51 HRS at Mathura Jn. Station between section Mathura-Palwal; Train No: 12 Car EMU of Train no 04446 arrived at 22:49 hrs on PF2A. Charge of train handed over by LP Shunter Govind Hari Sharma to ETL staff/MTJ. Front coach no. NR 238188 (DPC) dashed with dead end (AGC side), which resulted in all 4 wheels of leading trolley being lifted onto PF2. Hit OHE mast near the station name board.

2. Prima Facie cause: Carelessness of on duty ETL staff.
3. OBSERVATIONS:
  - a. CREW duty hours were within limit.
  - b. LP Sh Govind Hari left the cab without following laid down procedures.

- c. Maintenance staff ETL/Helper Sachin was on mobile.
  - d. As per CVVRS video, ETL/Helper Sachin arrived in cab and kept bag on throttle.
  - e. Throttle operated & train moved.

- f. There are four staff nominated for night stabling rake.
  - g. The Maintenance staff ETL/Helper Sachin was found in drunk stage as per BA report.

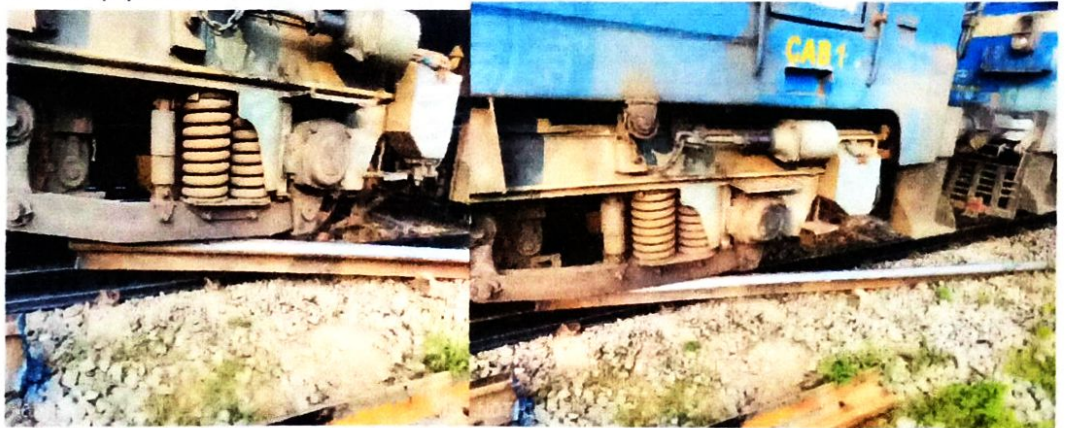
1. On 29.08.2023m Train No. N/JSWT, loco No. 27941/27956 KGP left LJR station of SBP division and at 06:51hrs & at about 07.10hrs, LP stopped the train with application of emergency brake at KM 259/31-33 between LJR-AMB due to a rail piece of approximately 13.03mtr **lying across** UP line track. Loco dashed with rail piece and dragged for 14-15 mtrs infringing UP line. The LP with the help of contractual workers at site removed the said rail piece from the track and left at 07.29hrs from site.

- There was old UMLC which got closed on 10.12.2015 has active trespassing path and the location is in a 1 degree curve with poor visibility.
  - Released panel rails were placed near the track at a distance of approximately 2.5 feet. Gas cutting of released rail was done in two parts i.e. 7.30mtr and 13.03mtr on 28.09.23 which was left on site near the old LC gate.

- Patrol man passed the site at 04.40hrs and train No. BCN/BHC passed the site at 06.40hrs prior to N/JSWT without any obstruction. But within 30 minutes the rail piece moved across the line and dashing happened.

- The released materials should be kept at adequate distance from the track site properly so as not to infringe the track. Trespassing to be strictly prohibited.
