EAST COAST RAILWAY

**Office of the
Chief safety officer,
Bhubaneswar.**

ALERT ADVICE-31

Sub:- Major Safety Unusual in ECoR

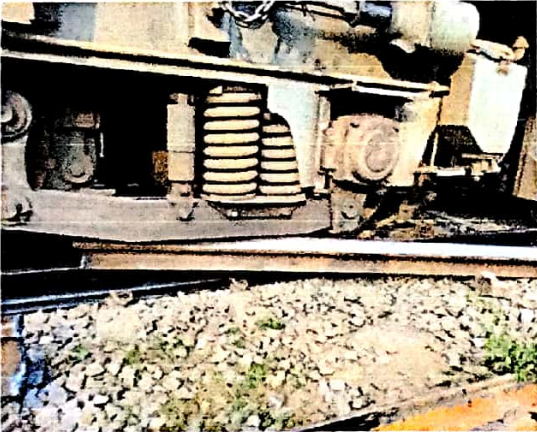
SN	BRIEF OF THE INCIDENT	LESSON LEARNT/ACTION TO BE TAKEN
A	<p>1. On 26.05.2023; 12246 (BBS-HWH) Duroonto EXP hit a full length rail piece at KM 309/18 between MZZ-KED Dn line on track and engine stopped at KED PF-03 at 12:24 hrs. Loco sand box broken & in hanging condition, Foot step of CAB-2 (LP side), Rail guard & cattle guard bend. There is no Engg signal or Caution order at the location.</p> <p>2. On 29.9.23 at Lanjigarh Road - Ambadola section, Released Rail infringing track at UP line -KM-259/13; Hit by goods train number ME/N/JSWT at 6.45 hrs.</p>
