## **EAST COAST RAILWAY**

**No:- ECoR/SFY/Alert advice-39/2024/519**

### **ALERT MESSAGE-39**

**Sub:- Recent accidents & unusual incidents in ECoR due to human failure.**

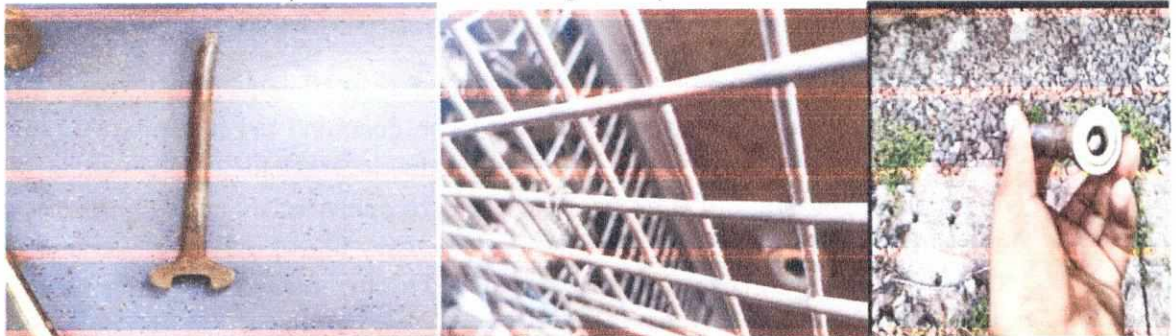
10. On 29.05.2024 Train no. 20841 Bhubaneswar-Visakhapatnam Vande Bharat Exp was detained at Huma station for auxiliary reservoir drain cock of 1<sup>st</sup> coach broken due to hitting with spanner of key man which was kept beside the track in between Rambha-Huma section. The key man left site leaving the spanner.

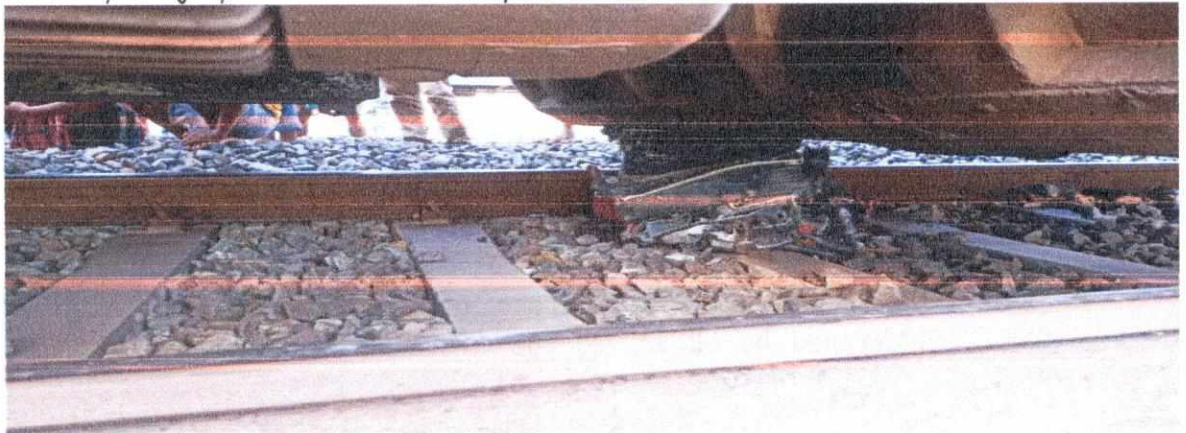
11. On 13.06.2024 at 16:03 hrs train No 12868 Puducherry - Howrah Exp dashed with rail dolly bearing welding machine at km 428/20-18 near MCS DN Adv Starter between Mancheswar - Bhubaneswar New of KUR Div while returning after block for renewal of glued joint & welding with Agency workers under supervision of Section PWI/MCS. No casualty & injury. Train detained at spot for 44 mins.

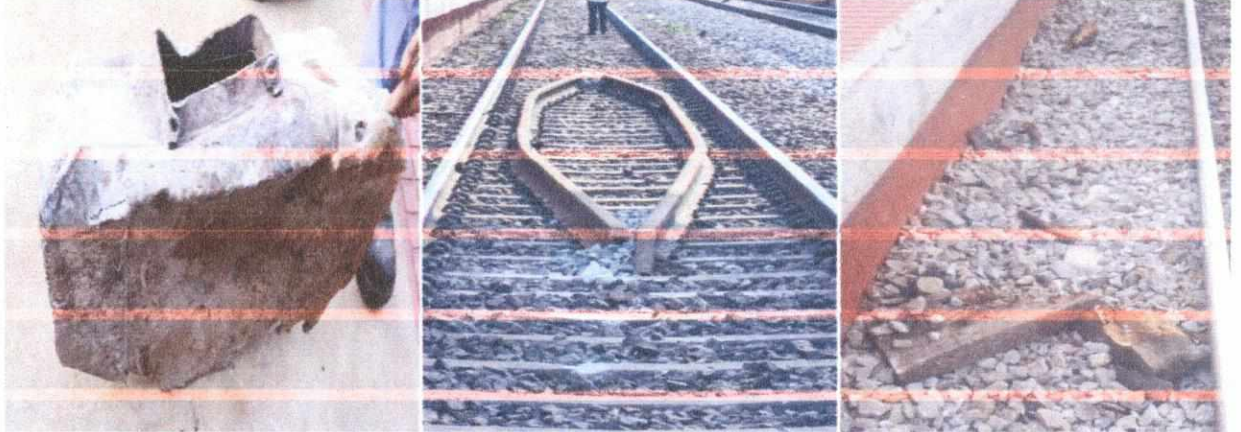
13. On 01.07.2024 at Kuhudi station of KUR Div, train no. 22641 Dn Shalimar Exp stopped at km 505/14-12 as BP dropped due to BP pipe of coach-B/2 burst. Sand box no. 5 of loco entangled, hit Platform coping, leading to damage of water tank and BP hose pipe of B2 coach. Foot step of rear cab got bent. Earth cable detached from wheel no. 7 of loco. Guard rail was broken at welding point. Distant block broken. Traffic affected for 39 min.

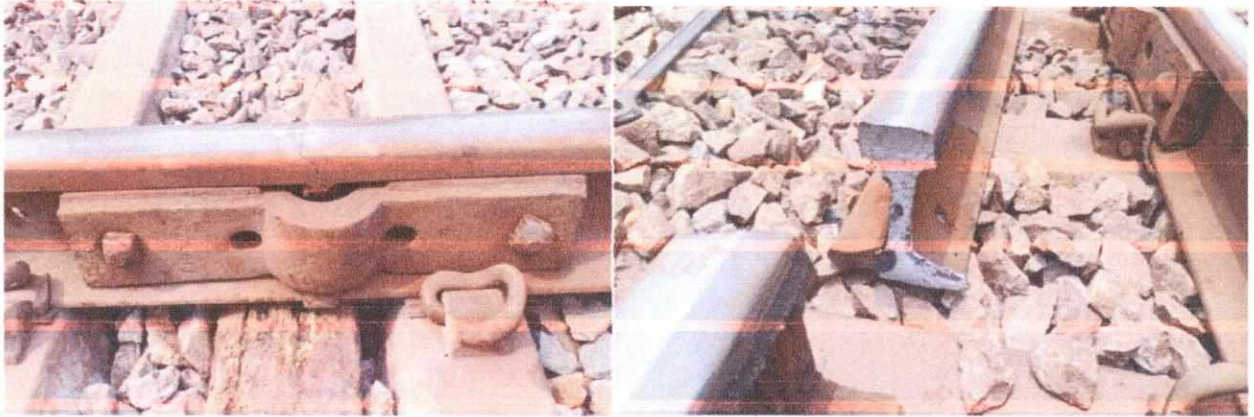
14. On 19.06.24 at 16:30 hrs on DN line at km 309/24-26 between Kenduapada - Manjuri Road of KUR Div, premature weld failure, detected by Keyman Sri Umesh Chandra Jena. 30 Kmph speed restriction imposed.
