## EAST COAST RAILWAY

No:- ECoR/SFY/Alert advice-40/2024/ 598

### ALERT MESSAGE-40

**Sub:- Rail fractures & Weld failures affecting train operation.**

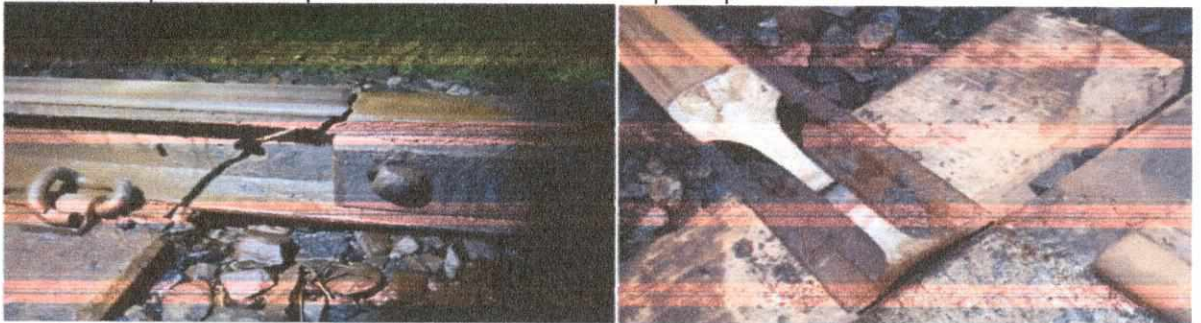
1. On 10.08.24 at 00.45 hrs at km 405/10-12 in CBT Yard DN main line of KUR Division a Rail fracture reported by Tech-II(S & T) Sri P.K.Sahu at Charbatia Station. Joggle fish plate was provided at the welding but there were extra holes on rail beyond it. Last USFD done on 20.07.2024 without detection of any flaw. The crack has developed from an outermost bolt hole.

Trains are passed on Speed restriction of 20 Kmph imposed at CBT till rectification.

Proper USFD testing, timely removal of overage rail and weld, timely distressing, emphasis on visual examination of bolt hole area and juggle fish plated area, proper maintenance of joints at point crossing area and at bridge approaches etc are essential. Seminars and demonstrations to be conducted involving departmental USFD operators and outsourced staff engaged in USFD testing and to be monitored by HQ Officers at higher level at regular interval to eliminate the limitation in operational skills of USFD operators and maintenance practices of assets impacting Rail/Weld failures.

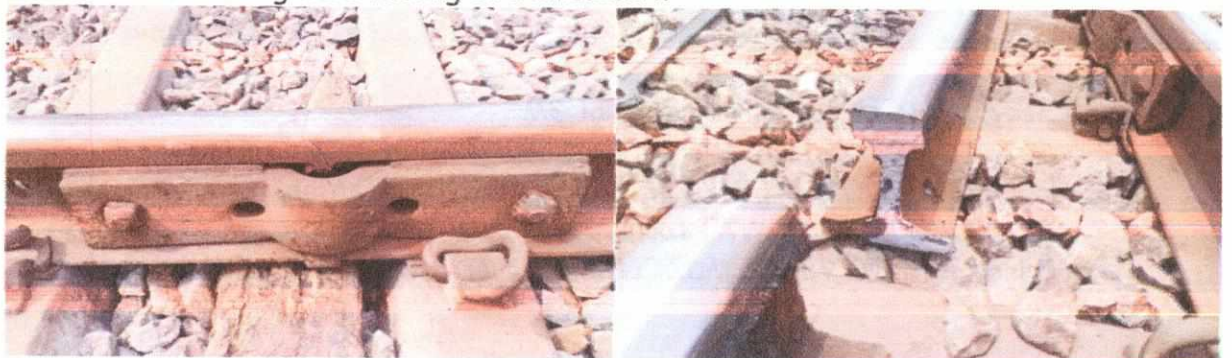
2. On 19.06.24 at 16:30 hrs on DN line at km 309/24-26 between Kenduapada - Manjuri Road of KUR Div, premature weld failure, detected by Keyman Sri Umesh Chandra Jena. Rolling mark 60 Kg SAIL of 08/2020. Total GMT carried only 31.492. USFD testing of Weld was done on 24.03.2024 & Rail on 10.06.2024. No flaw was detected. Welding date is 27.11.2023. Distressing was done on 11.11.2023. Flaw in flange area is clearly visible which could have been detected during weld testing on 24.03.2024.

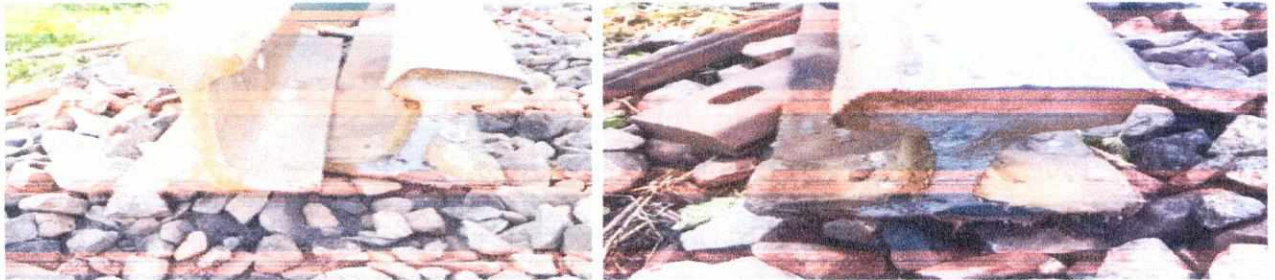
3. On 16.07.24 at 06:40 hrs, AT weld failure reported by Keyman Sri R.K. Sharma at Muniguda station on DN line at km 287/0-2 between Doikallu-Muniguda of SBP Division. Weld test was done on 05.11.2023 & Rail test was done on 16.06.2024 and the result was reported good weld. But there was a 'half moon flaw' which could have been detected during weld testing by hand probing. As report in TMS, the year of weld was 2008. At the time of weld failure it crossed 625.5 GMT. That is overage weld. This welded rail was laid after GFTR during May 2022.

Trains are passed on Speed restriction of 30 Kmph at MNGD till rectification.

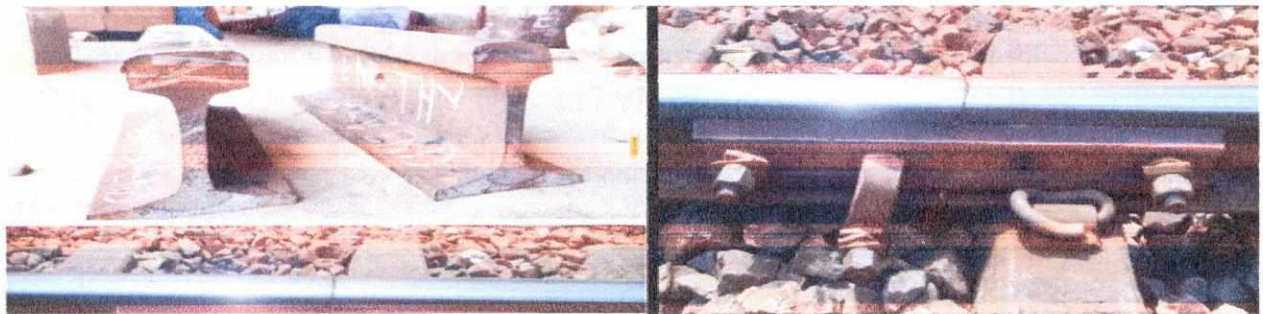
4. On 12.08.2024 at 01:15 hrs on DN line at km 306/2-4 between Bisamcuttack-Therubali of SBP Division, a Rail fracture was detected by Sri Manmath Panda, Helper-II(S & T). The Rolling mark of Rail is 60 Kg SAIL April 1999 and laid on track in Feb-2000. Date of last USFD testing was on 16.07.2024 and no flaw was detected. The rail has already crossed 813 GMT. Speed restriction of 30 kmph imposed by SSE/P.way/MNGD.
