# EAST COAST RAILWAY

## ALERT MESSAGE-45

Sub:- Defective wheel (Flat Tyre, Hollow tyre, Thin flange, etc.); cause, repercussion, action taken and prevention.

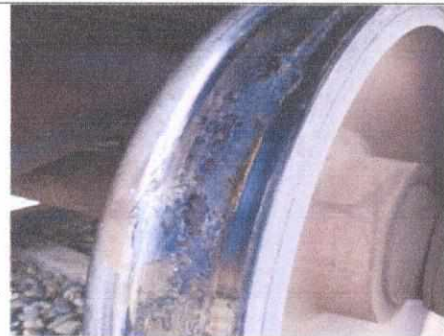
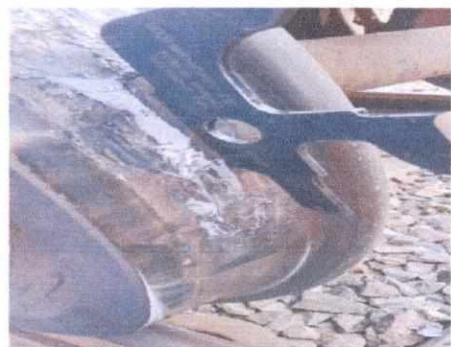
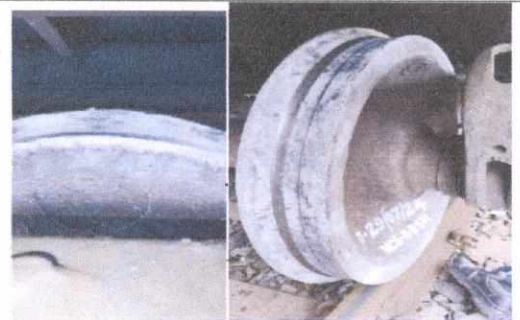
SN	CASE STUDY
A	<p>On 01.01.2025 at 06:30 hrs at BBSN Station of KUR Division Flat tyre in the 1st wagon (BLCA 61250625283) from Engine of Train no. E/CCJS/CONT detected which measured 70mm;</p> <ul style="list-style-type: none"> <li>➤ While passing through CTC, LP was reported of brake binding next to engine, controlled at Gopalpur-Balikuda PH; found metal deposit on wheel and release brake binding.</li> <li>➤ After start LP noticed abnormal sound on run, reported &amp; controlled at BBSN, on checking found Flat Tyre of approximately 70mm in L4 wheel and Skidding mark in other wheels of said wagon. R2 CC spring loaded side bearer housing cracked and L4 bearing CTRB backing ring found cracked.</li> <li>➤ Hand brake was found in partially applied condition.</li> <li>➤ Last POH: 31.01.22 at PWP, Last ROH: 27.09.23 at WATK, Return date: 09/26.</li> </ul>
B	<p>On 29.07.2024 at 03:30 hrs Nine wagons of train No. UP ME/TPAK-243 goods got derailed on Middle line of MCS yard R/7 obstructing Middle line.</p> <p>Divisional JAG Inquiry committee found Hollow tyre/false flange having 9mm in 3<sup>rd</sup> wagon. The false flange has entered in between tongue rail &amp; stock rail on RH side (closed condition of tongue) during movement of train in trailing direction of point no. 61B.</p>

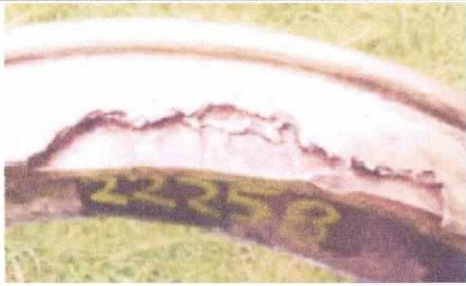
Sl. No	Type of wheel defects	Causes of defects	Visual detection during primary / secondary maintenance
1	Shattered Rim	<p>Wheel with a fracture on the tread or flange.</p> <p><b>Action:-</b>It must be withdrawn from service.</p>

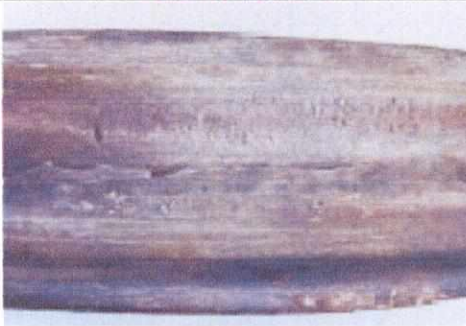
<p>Shattered Rim</p>
2	Spread Rim	<p>If the rim widens out for a short distance on the front face, an internal defect may be present. Spreading of the rim is usually accompanied by a flattening of the tread, which may or may not have cracks or shelling on the tread.</p> <p><b>Action:-</b>Such wheels must be withdrawn from service.</p>

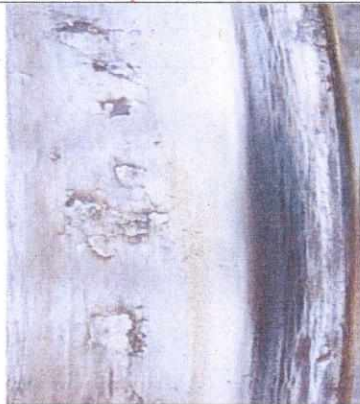
<p>Shelled Tread</p>

<p>Spread Rim</p>
3	Shelled Tread	<p>Shelling can be identified by pieces of metal chucked/breaking out of the tread surface in several places more or less continuously around the rim. Shelling takes place when small pieces of metal break out between the fine thermal checks. These are generally associated with small skid marks or "chain sliding."</p> <p><b>Action:-</b>Such wheels should be withdrawn from service.</p>

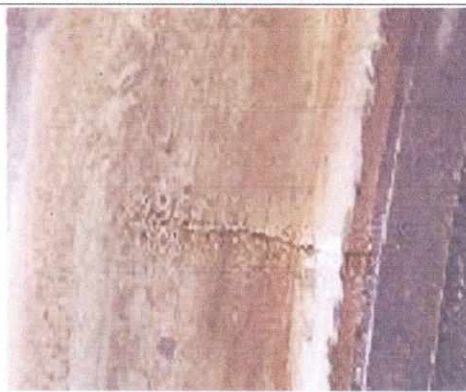
<p>Thermal Cracks</p>

4	Thermal Cracks	<p>Thermal cracks appear on a wheel due to intense heating of the wheel arising out of sever brake binding. Such cracks occur on the tread and generally progress across the tread in a transverse &amp; radial direction.</p> <p><b>Action:-</b> Whenever such a crack becomes visible on the outer face of the rim or a tread crack has reached the outer edge (non-gauge face) of the rim; the wheel should be withdrawn from service.</p>

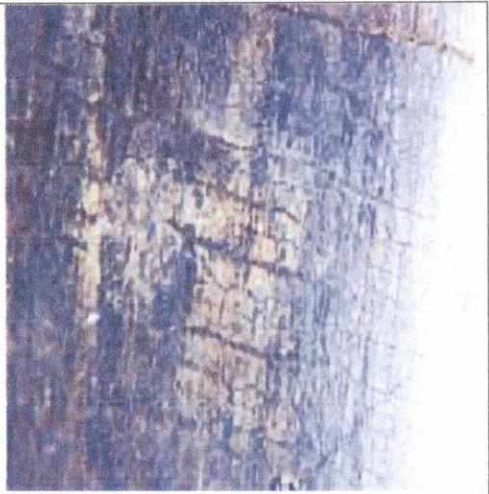
<p>Heat checks</p>
---	-------------	--	---

5	Heat checks	<p>Thermal cracks are deeper and need to be distinguished from fine superficial cracks visible on the tread on adjacent to the braking surface. This defect is also observed with the brake discs on LHB coaches.</p> <p>These are called heat checks, which are usually denser than the thermal cracks. Heat checks are caused on the tread &amp; on the brake disc due to heating and cooling cycles undergone by the wheel &amp; disc during normal braking cycles.</p> <p><b>Action:-</b> Such wheels do not need to be withdrawn but should be carefully distinguished from the rejectable thermal cracks</p>
