System Improvements 2024-25

System Improvements Contd....

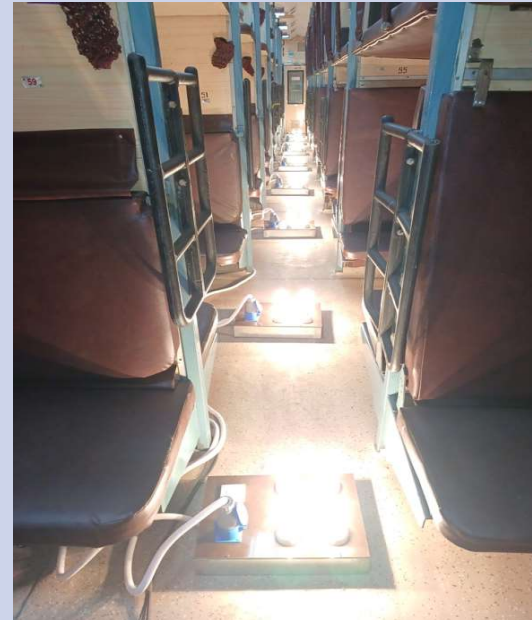
II. Load testing of RMPUs being done in AC coaches with heat load.

Proforma to Record Pull Down Test

1. Coach No. & Type	212356 / LWACCN		
2. Supply voltage	415 V		
3. Ambient temperature	29° C		
4. Electrical compensating heat load provided	16.8 KW		
5. Date of testing	17.12.2024

Temp. rating at position 6 (i.e. 24.9° C)	Time when compensating electric load switched "ON"	Time when both plants switched "ON"	Coach Temperature when both plants switched "ON"	Time of plants rating "OFF"		Coach Temperature when both plants switched "OFF"	
				Plant-1	Plant-2	Plant-1	Plant-2
Yes	14.00 Hrs	14.03 Hrs	49° C	15.50	15.50	24.4° C	24.4° C

Time	Temperature
14.03 Hrs	49° C
14.20 Hrs	34.3° C
14.35 Hrs	31.5° C
14.50 Hrs	30.8° C
15.05 Hrs	27.4° C
15.20 Hrs	26.2° C
15.35 Hrs	25.3° C
15.50 Hrs	24.4° C

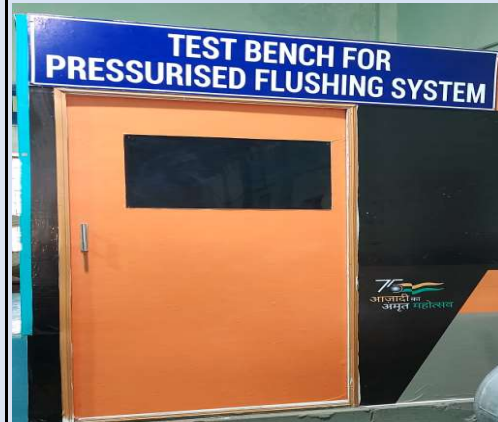
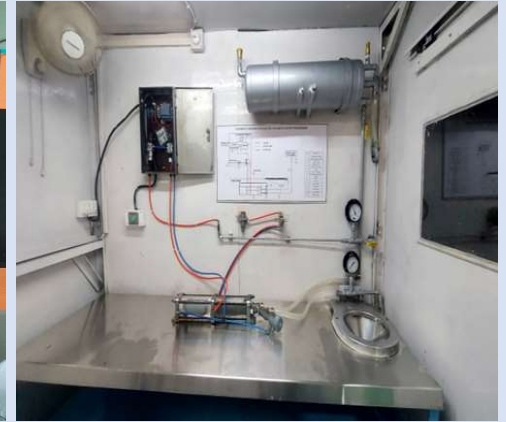
III. Test bench for pressurized flushing system:-

Developed in house at water pipe section in the month of Oct' 2024. Pressurized flushing cylinders are overhauled and tested in the test bench.

Suitable for testing of all makes of pressurized cylinders.

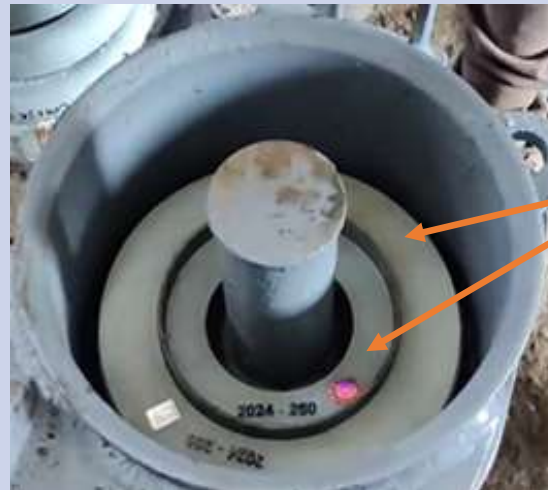
IV. TPU Fitment as per RDSO letter No. SV.FIAT Spring dated 07.06.2024

TPU ring

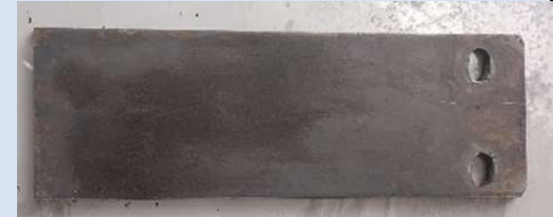
V. Modified Stiffener Plate:

Provision of stiffener plate of CBC as per revised specification of RDSO Lr.No.MC/BLB/CBC dated 28.02.2024

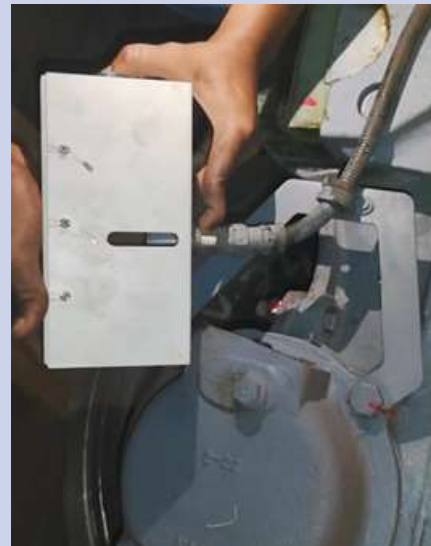
VI. Polaroid Simulator being used to ensure WSP system integrity.

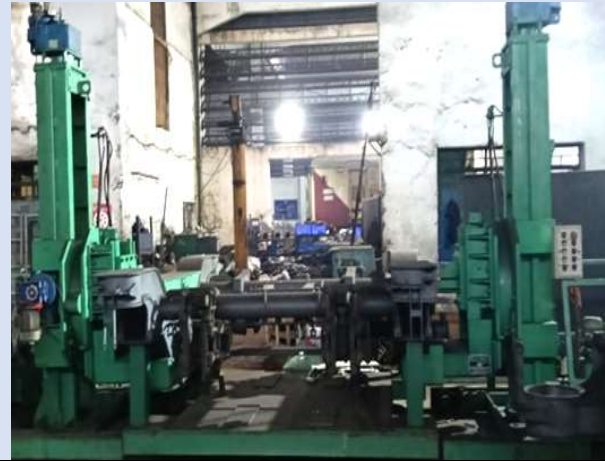
VII. Bogie Manipulator Commissioned on 26.09.2024 at Bogie repair shop for best welding quality in Bogies.

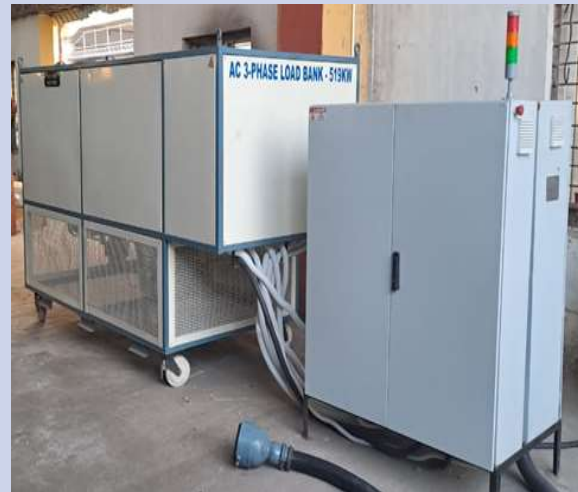
VIII. Power car load test bench (Resistive load bank 500KW) commissioned on 13.12.2024 to ensure reliability of DG sets in Power cars.

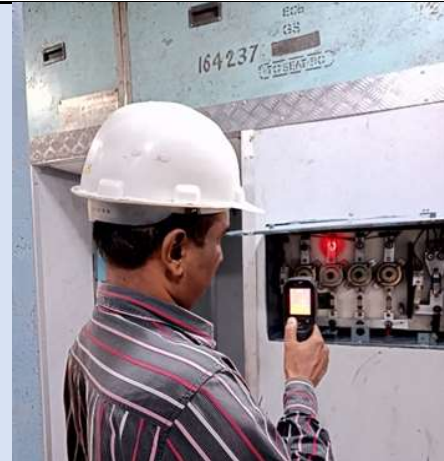
IX. Thermal imaging camera is being used for testing.

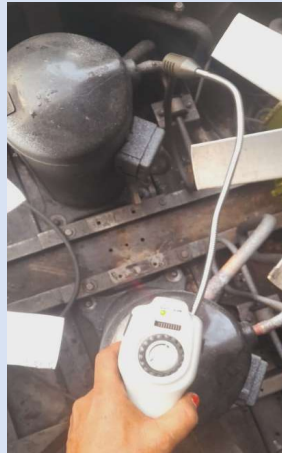
XI. Refrigerant leak detector is being used for identifying the leakage in RMPU units.

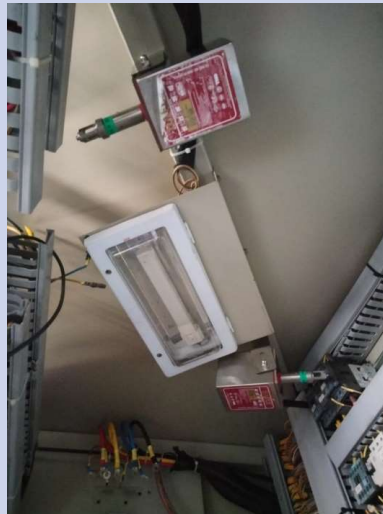
XII. Provision of Aerosol fire suppression system in the electrical panel of LHB coaches.

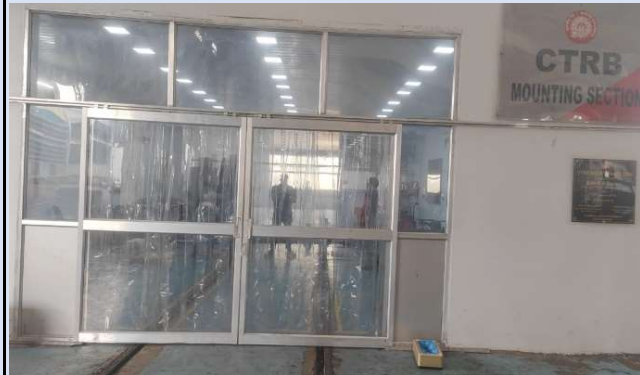
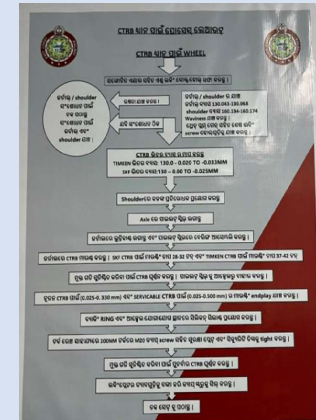
XIII. CTRB Mounting section:-

Glass sliding door have been provided with plastic Split curtains and shoe cover machine for dust free environment of CTRB mounting.

Instruction board displayed in regional language for understanding the process easily.

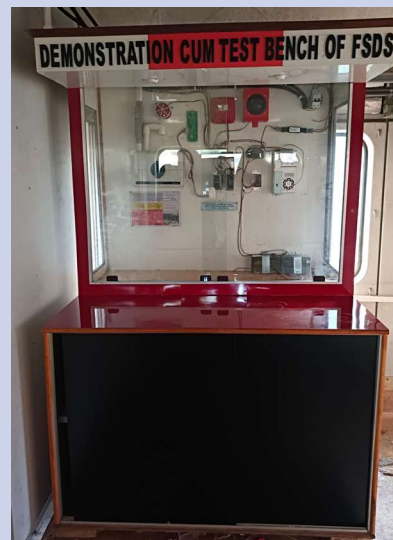
XIV. Test bench for FSDS .

Developed by inhouse

Utilised for demonstration of FSDS

Testing of FSDS parts like modules ,SMPS, display card, PA system, strobe light etc.

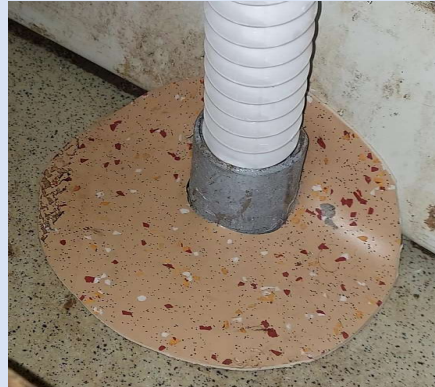
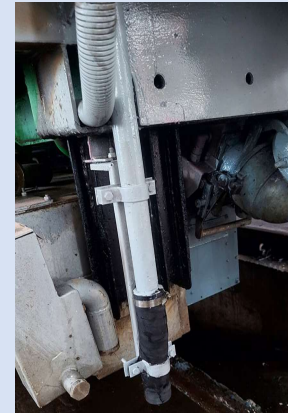
XV. Implementation of CAI regarding lavatory wash basin drain outlet pipe laying for waste water.

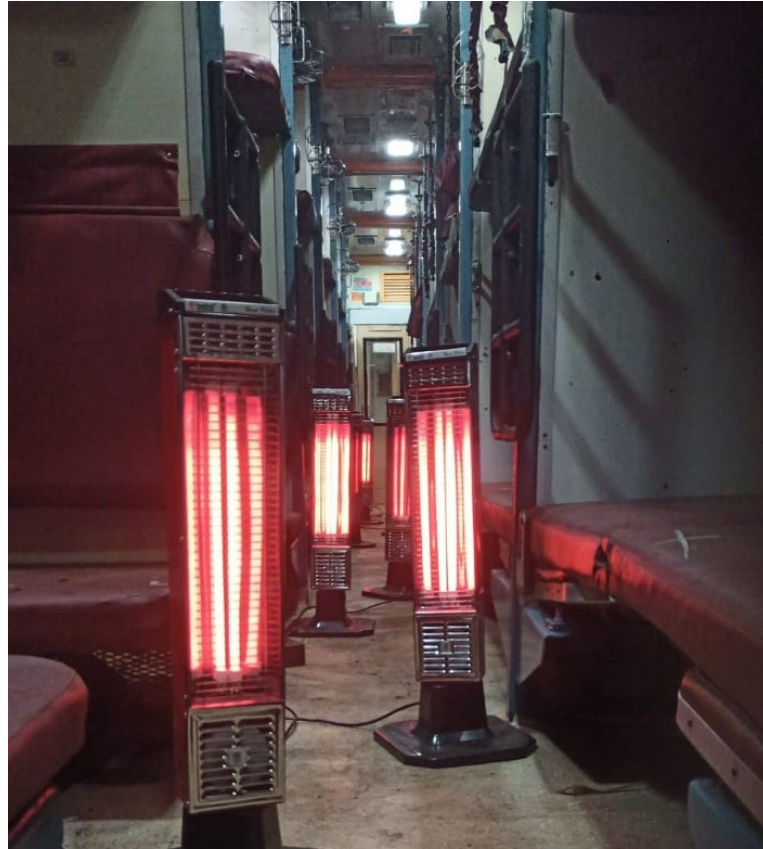
**Load testing of RMPUs being done in
AC coaches with heat load.**
