# MONTHLY SAFETY BULLETIN

MAR-2022

**Zonal Safety Organization  
East Coast Railway, Bhubaneswar**

| Sl No. | ITEMS | PAGE |
|---|---|---|
| 2. | COIL SPRING BREAKAGES IN LHB COACHES, An analytical discussion<br>Sri J.V Appa Rao, Dy.CSO/Mech | 5-12 |

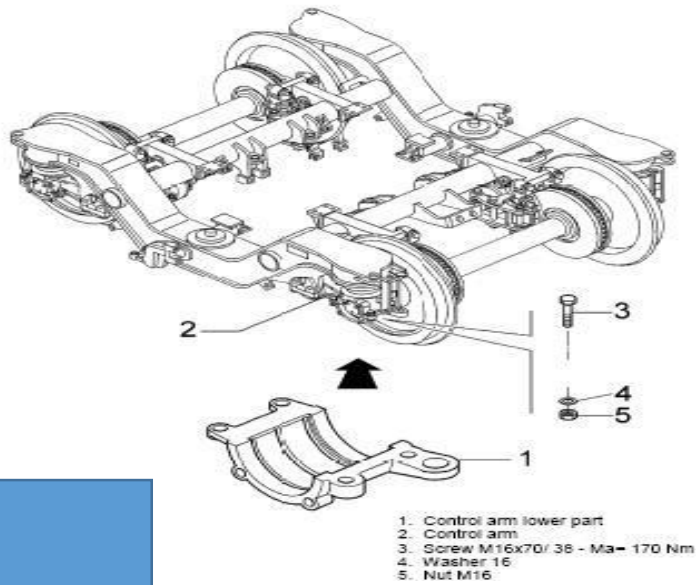
Wrong  
practice

After lowering the frame over the wheelsets, mount the lower parts of the control arms (1 - FIG. 4-75) to the upper one (2): insert the screws (3), the washers (4) and the nuts (5) and tighten them.

Right  
practice

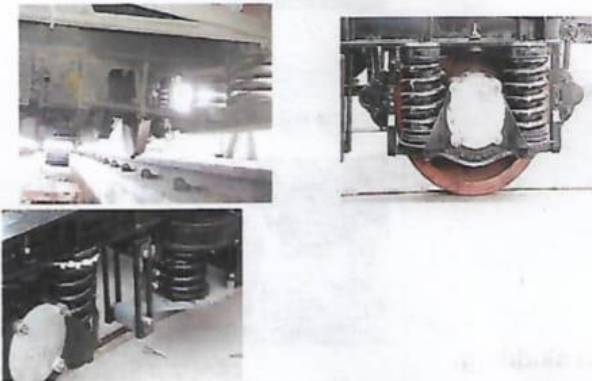
| SN | Component | Remarks |
|---|---|---|
| 01 | <b>Hanging Part</b><br>Equalizing stay rod<br>Axle box cover etc.<br>J-Bracket,<br>Truss bar,<br>Hanger | |

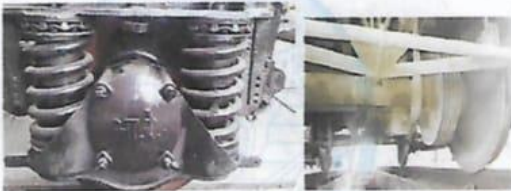
| SN | Component | Remarks |
|---|---|---|
| 02 | <b>Hot axle</b> | <br><b>Smoke from axle box bearing</b> |

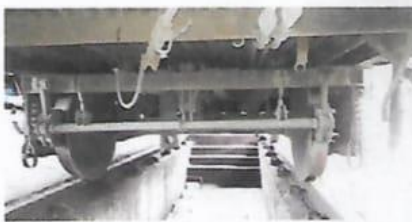
| SN | Component | Remarks |
|---|---|---|
| 04 | <b>Air Pressure leakage</b> | <b>Hissing sound from air brake pipes</b><br> |
